S417-04

TECHNICAL BULLETIN

Headlamp Internal Condensation – Acceptable Levels – Repair Guidelines

MODEL 2003 MY-ON
S-TYPE

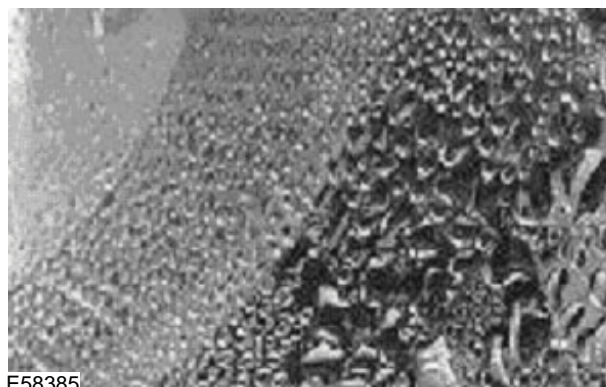
ILLUSTRATION 1

1. Large apparent visible droplets of water on the interior side of the clear glass lens.

VISIBLE DROPLETS OF WATER ON INTERIOR OF CLEAR GLASS LENS

1. Turn the headlamp dip and main beam functions 'ON', and run the engine for 30 minutes.
 - If water droplets still remain on the inside of the headlamp glass, the lamp should be renewed.
 - If there is evidence of standing water within the headlamp unit, the unit will also need to be replaced.For additional information, refer to Global Technical Reference (GTR) Workshop Manual, section: 417-05, Headlamp Assembly.

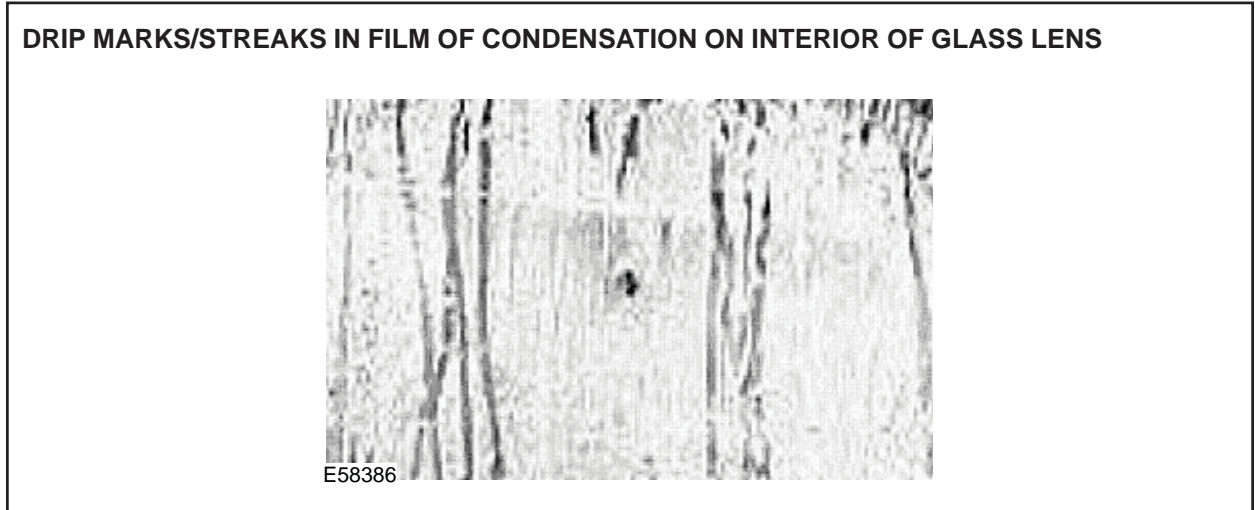
ILLUSTRATION 2

2. Drip marks/streaks in the film of condensation on the interior side of the glass lens.
