V8 XJ Series

## TECHNICAL BULLETIN

Engine Block Heater – Install Power Cord –  
Service Action S686 –  
Canadian Market Vehicles Only

MODEL 1998 MY-ON  
V8 XJ Series

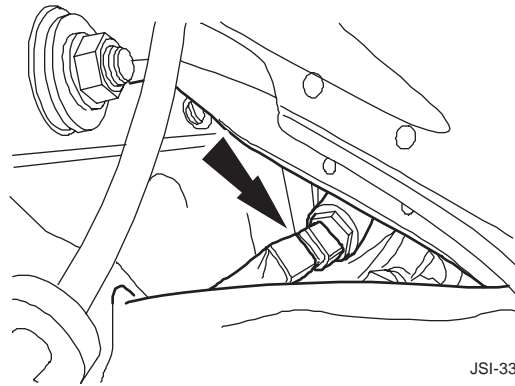
ILLUSTRATION 1

**POWER CORD CONNECTED TO BLOCK HEATER**

5. Connect the power cord to the block heater, then route the cord downwards and towards the front of the vehicle, as shown in Illustration 1.

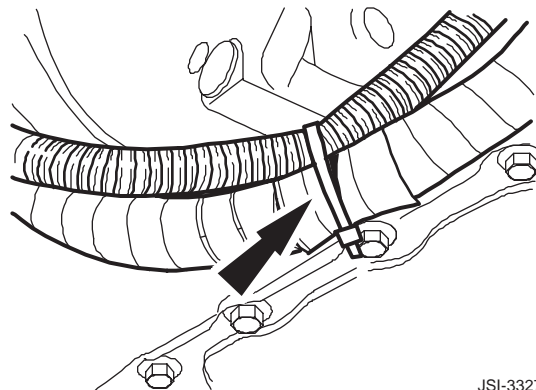
ILLUSTRATION 2

**CORD SECURED TO PAS HOSE**

6. Pass the power cord forwards and downwards, over the suspension crossmember, so that it can be attached to the power steering feed hose, at the ferrule, using a tie strap as in Illustration 2. Trim off any excess length of tie strap.

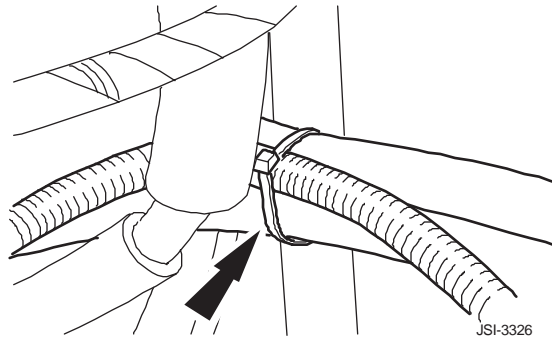
ILLUSTRATION 3

### TIE STRAP TO GEARBOX COOLER HOSES

7. Route the power cord forwards, upwards and outwards, until it can be positioned between and outboard of the two hoses connecting to the gearbox oil cooler. An additional tie strap should be installed at this point, as in Illustration 3. Trim off any excess length of tie strap.
8. Route the power cord forwards, towards the air intake aperture in the bumper cover, passing outboard of the radiator support bracket.

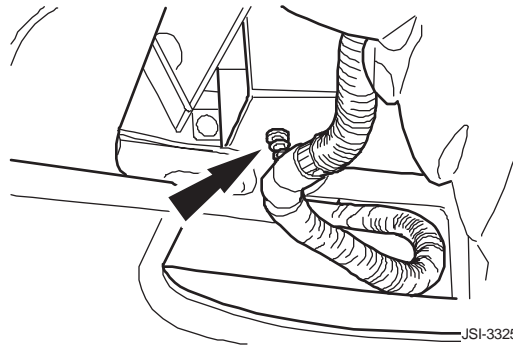
ILLUSTRATION 4

### FIR-TREE INTO RADIATOR BRACKET

9. Insert the fir-tree fastener into the existing hole on the underside of the radiator bracket, as in Illustration 4.

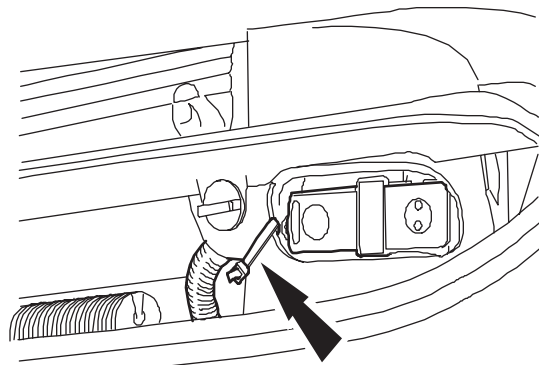
ILLUSTRATION 5

### SECURING CONNECTOR TO GRILLE

10. On naturally aspirated vehicles, route the power cord forward until it can be positioned to the front of the air intake aperture, below the splitter vane, as in Illustration 5. Attach another tie strap to retain the power connector. Any excess length of power cord should remain supported on the left hand side of the bumper cover.

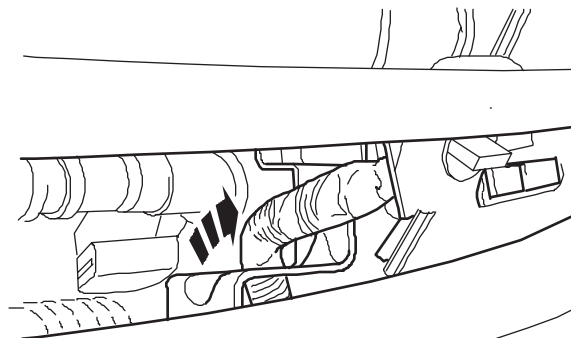
ILLUSTRATION 6

### ADDITIONAL BRACKET ON SUPERCHARGED VEHICLES

11. On supercharged vehicles, following step 9 above, ensure that the power cord is routed behind and then over the additional cooler support bracket (as shown in Illustration 6 - viewed through the air intake opening) before completion as in step 10 above.
12. On all vehicles, reinstall the wheel well liner and wheel.
13. Lower the hoist, then fully tighten the wheel lug nuts.
