SERVICE ACTION

Service Action Number:
S514

Throttle Closed Position Operation

Publication No.:	303-S514
Model:	XK Series N/A vehicles
Model Year:	1997 to 1998
VIN Range:	001036 to 031302
Model:	XK Series SC vehicles
Model Year:	1998.75 to 1999
VIN Range:	024695 to 042775
Model:	V8 XJ Series N/A vehicles
Model Year:	1998
VIN Range:	812256 to 853935
Model:	V8 XJ Series SC vehicles
Model Year:	1998 to 1999
VIN Range:	812256 to 878717
Date of Issue:	13 May 2004

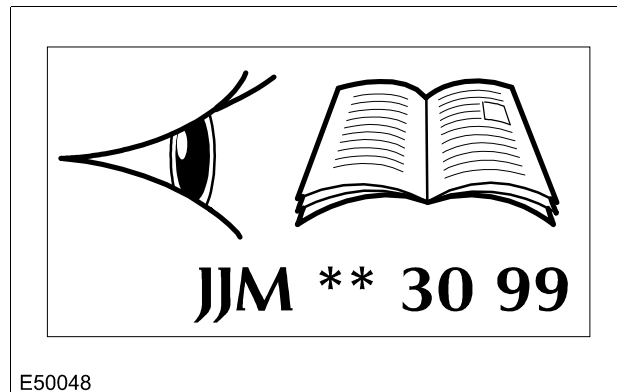
Fig. 11

Note: The new throttle body has a molykote coating and can not be cleaned. The new throttle bodies can be identified by a sticker. See Fig. 11.
