**S-TYPE**

S501-21

SERVICE**TECHNICAL BULLETIN**

**Sliding Roof One-Touch Issues –
Resynchronize Roof Panel & Reprofile Spring
– Repair Procedure**

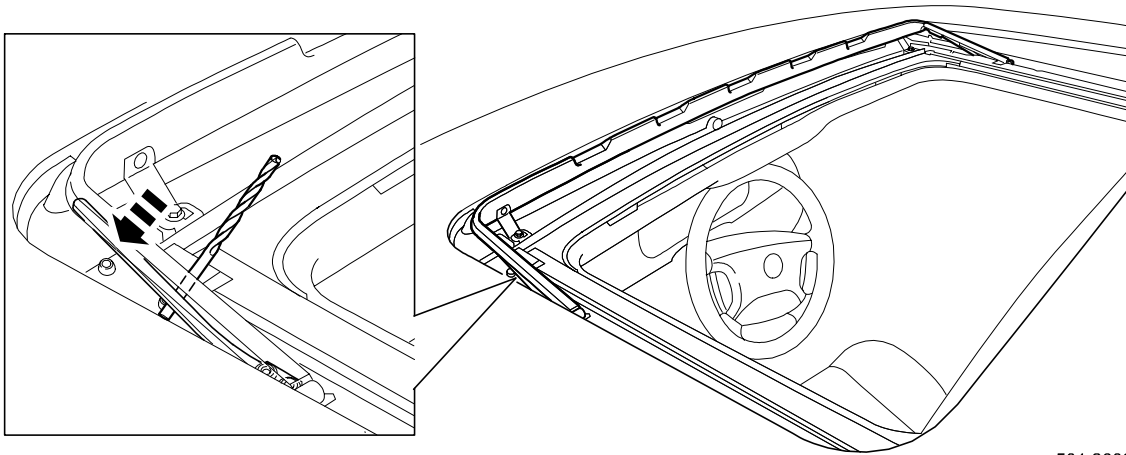
ILLUSTRATION 1

On some 2003-04 MY S-TYPE vehicles within the above VIN range, there is a possibility that the roof opening panel may not close on one-touch operation and may 'bounce back'. This condition may be caused by excessive strength of the wind deflector spring .

4. On the left side of the vehicle, position the shank of a 4.0 mm twist drill under the base of the spring by the rivet head. Push the deflector down over the drill until it bottoms out to reprofile the spring (Illustration 1).
5. Carry out step 4 for the right hand side of the roof opening panel.
