TECHNICAL BULLETIN

Momentary Engine Power Loss or Stalling Diagnosis and Repair

18-38

MODEL **91-94 4.0L Sedans**
93-94 4.0L XJS

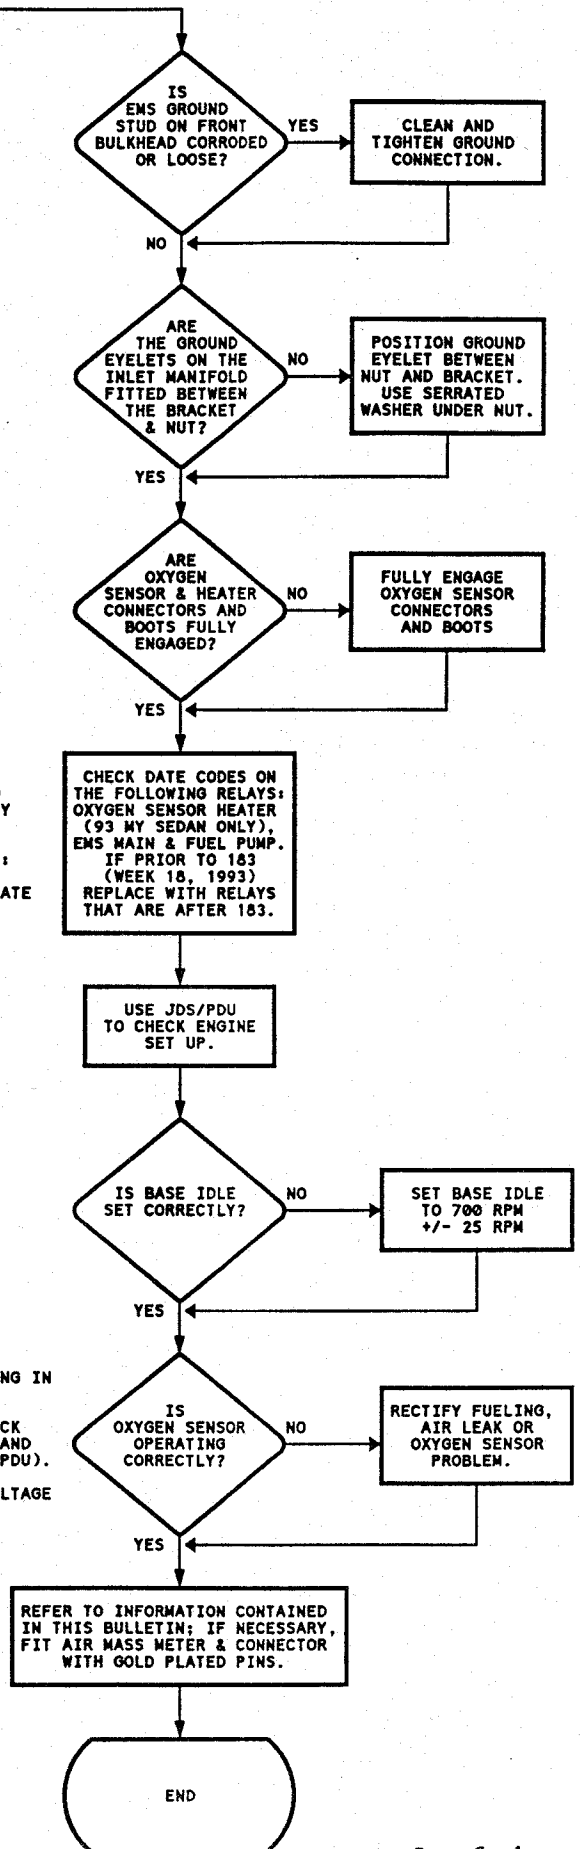
STALLING CAN BE CAUSED BY DIRT ACCUMULATION ON THE HT TOWER WHICH LEADS TO HIGH TENSION TRACKING.

WHEN ENGINE IS RUNNING IN CLOSED LOOP:

OXYGEN SENSOR FEEDBACK SHOULD BE BETWEEN 1 AND 4 VOLTS (USE JDS OR PDU).

OXYGEN SENSOR RAW VOLTAGE SHOULD SWING BETWEEN 0.2 AND 0.8 VOLTS.
