Squeak or Groan From Bulkhead Area –  
Check Mounting of False Bulkhead –  
Repair Procedure

MODEL 1998 MY-ON  
V8 XJ Series

VIN 812256-ON

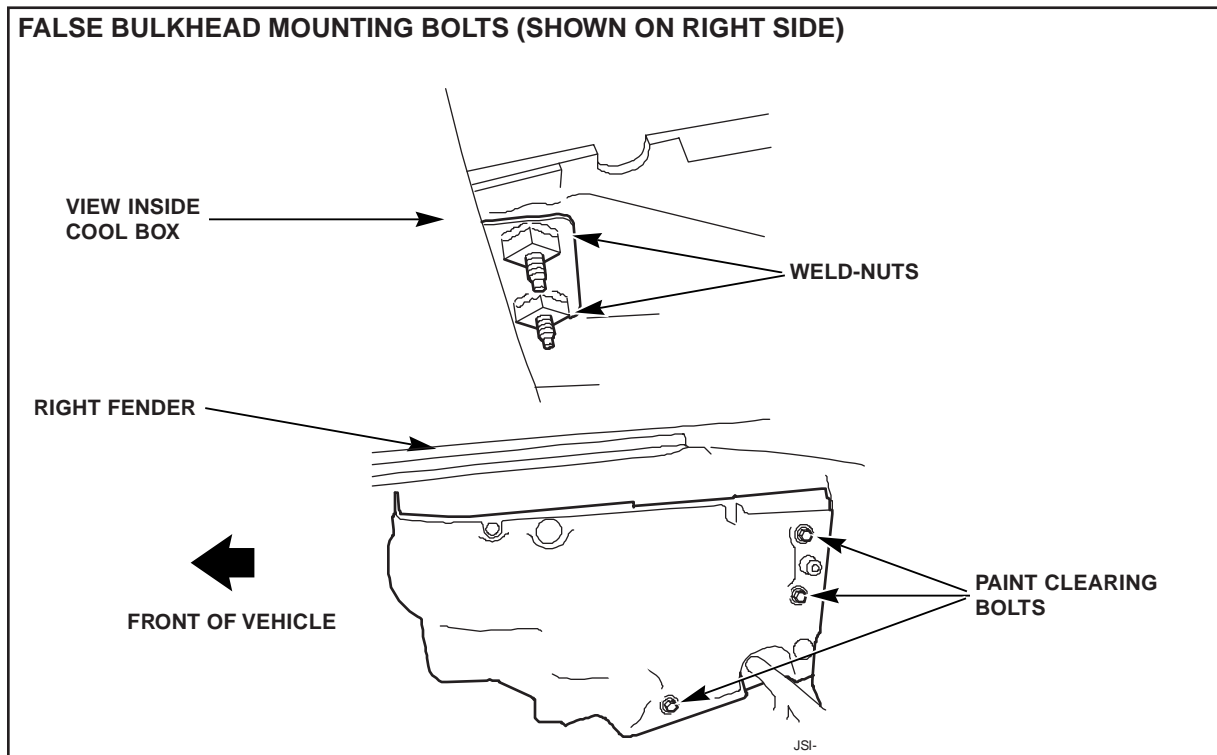
ILLUSTRATION 1

FALSE BULKHEAD AND BRACE

Inadequately tightened paint-clearing bolts (Illustration 1) that retain the plastic false bulkhead molding to its brace (triangular in shape) will allow the plastic to ‘fret’ against the metal brace plate, thus generating noise which is transmitted through the bulkhead and which is irritating to the occupants.

Inadequate tightening may be caused by either or both of the following:

- Bolts cross-threaded.
- Sound deadening panel trapped under the bolt head(s).

Loosen the three bolts by one turn, then road test the vehicle. If the noise has disappeared, the source of the concern has been pinpointed.

1. Carefully inspect whether the sound-deadening panel material is trapped under any of the bolt heads. If necessary, loosen the bolts to allow the material to be trimmed to clear the bolt heads, then retighten the bolts.

2. Attempt to retighten the three bolts. If this is impossible due to cross-threading of the bolt(s) and weld-nut(s), remove the affected bolt(s), using a hammer and chisel, (Illustration 1). (A sharp blow with a chisel will easily remove a weld-nut.) Install new bolts and nuts. Apply Loctite (Part No. JLM 1748) to the threads of the bolt before installing. Retrieve and discard any weld-nut which is removed, to avoid leaving in the vehicle the source of a rattle.

It is necessary that the bolts are tighten sufficiently to provide full clamping of the plastic molding to the triangular brace plate. Due to the restricted access a specific torque wrench setting is not appropriate.

3. Conduct a brief road test to verify the repair.
4. In case of a remaining squeak or groan apparently from the same area, hammer the flange of the plate which is spot-welded to the bulkhead and to which the triangular brace plate is attached. Use a hammer and drift to push the flange towards the bulkhead, particularly in the area of the recess towards the top of the plate.
