TECHNICAL BULLETIN

**Vibration When Braking –
Brembo Brakes Disc Thickness Variation –
Diagnosis/Repair**

MODEL 2004-05 MY
XJ supercharged
VIN G00442-G45704

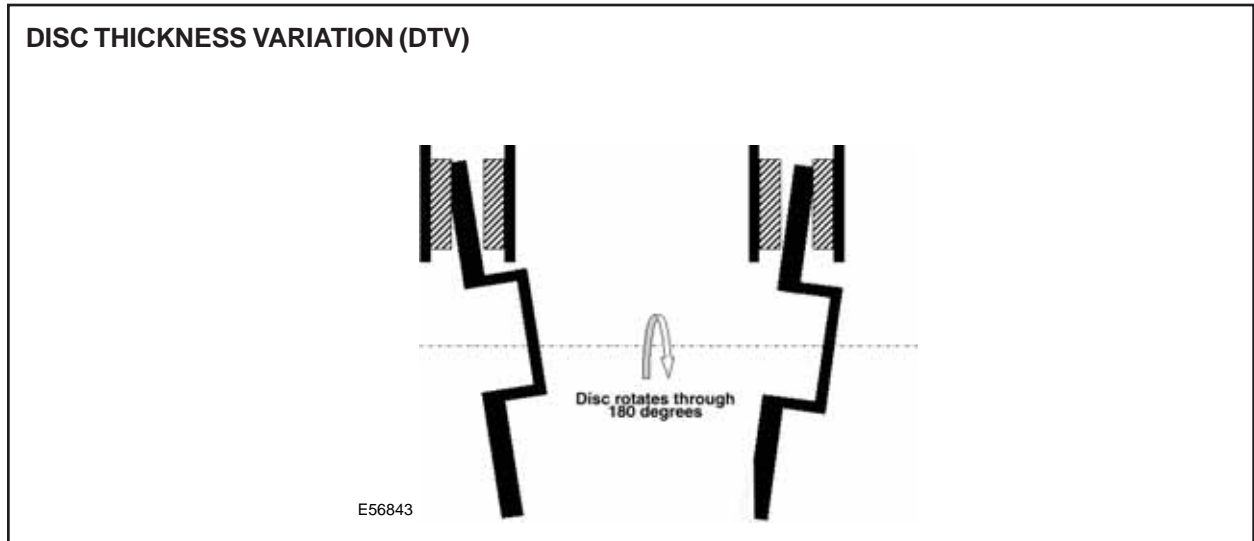
ILLUSTRATION 1

Vibration/shudder while braking is not necessarily caused by brake disc run-out (also referred to as warped discs, or out-of-roundness of the discs). It can also be caused by low levels of disc thickness variation (DTV) being present around the contact area of the brake disc. DTV is caused when a vehicle with moderate levels of brake disc run-out, drives many miles with very little braking activity, such as on a highway or freeway. The installation angle of the replacement discs and the rubbing of the brake pad on the high areas of the rotating brake disc when the brakes are not applied, cause the DTV. Refer to illustration 1.

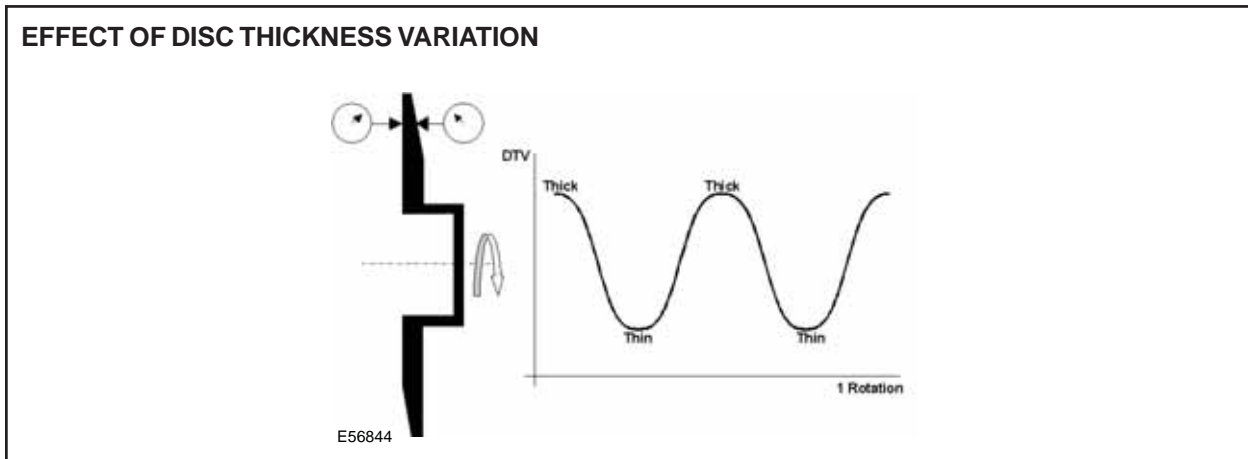
ILLUSTRATION 2

This incorrect installation angle may be due to contamination between the brake disc mounting surface and the drive flange, or a combination of drive flange run-out and brake disc run-out. Refer to illustration 2.

Note: It is essential to measure the disc run-out for diagnosis of the concern and when new discs are installed to prevent recurrence of the problem.

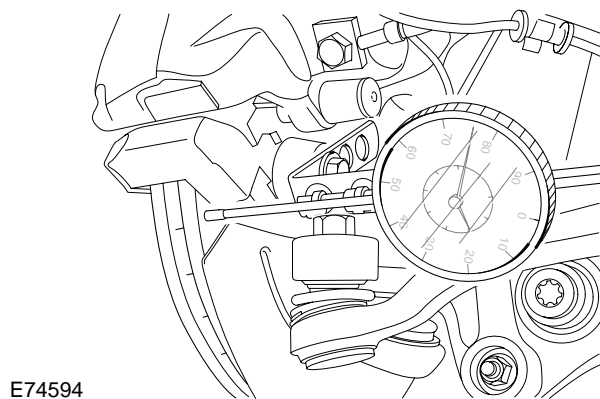
ILLUSTRATION 3

DIAL TEST INDICATOR MOUNTED ON VERTICAL LINK

4. Install the new brake disc to the drive flange and secure with at least three wheel nuts, tightened to a maximum of 4 Nm.
5. Mount a dial test indicator (DTI) to the inboard side of the vertical link using the caliper assembly lower bolt hole (Illustration 3).

6. Position the DTI probe 5 mm in from outer edge of disc.
7. Measure the disc run-out with one rotation of the disc.
 - If the measured run-out is less than 0.04 mm then go to step 20.
 - If the measured run-out is greater than 0.04 mm then go to step 8.
8. Remove the wheel nuts from the wheel studs.
