XJ Range

NUMBER XJ211-003

### **TECHNICAL BULLETIN**

**Steering Wheel Alignment**

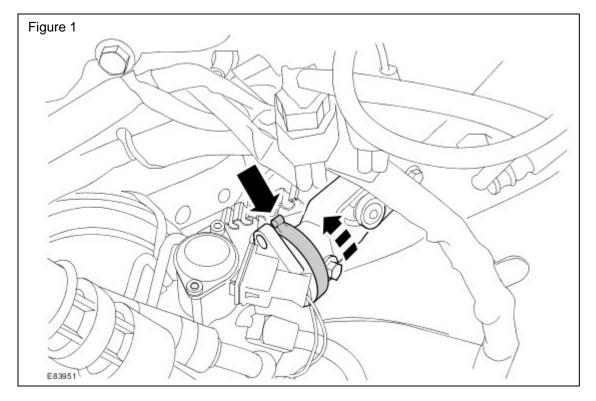
- 1. Raise the vehicle on a suitable lift.
- 2. Remove the vehicle undertray
- 3. With assistance, rotate the steering wheel to align the steering column to the boss on the steering rack pinion housing. (Figure 1)

- 4. Lower the vehicle.
- 5. Visually check the alignment of the steering wheel.
- 6. If the steering wheel alignment is less than ±3°, no further action is required.
