S-TYPE

S204-05

TECHNICAL BULLETIN

Rear Suspension Toe Links (Tie Rod Assemblies) – Larger Mounting Stud – Modification Procedure MODEL 2000 MY-ON S-TYPE

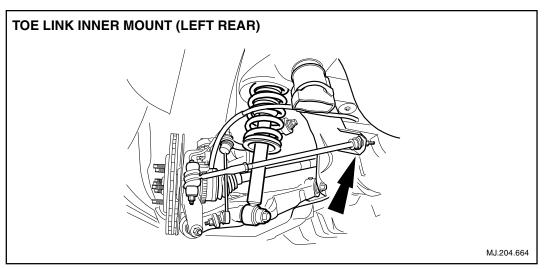
ILLUSTRATION 1

Beginning with VIN L06641, the inner mounting of the rear suspension toe links (tie rod assemblies) changed from 10 mm to 12 mm mounting stud diameter. Toe links of early design are no longer available. If a replacement toe link is required, it is necessary to modify the rear cross member to accept the later design of toe link. This modification must be performed on both sides of the vehicle and both toe links replaced with the later design, even if the original need was only to replace one toe link.

After removing the toe link (Illustration 1), enlarge the existing 10 mm mounting hole to 12.2 mm diameter.

Depending on availability, use a 15/32" drill, rotary file or hand reamer to enlarge the hole, ensuring that the finished diameter remains concentric with the existing hole.

Ensure that the specified 12.2 mm diameter is not exceeded.

- 2. Where necessary, use a hand file to clean up any drill swarf around the enlarged mounting hole.
- 3. Apply zinc-rich paint (depending on local availability) to protect the bare metal created by the drilling and filing operations.
- 4. Install the replacement toe link. Torque the inner stud mounting to 90 Nm (66 lb. ft.) Torque the hub carrier mounting to 100 Nm (14 lb. ft.)
- 5. Repeat the above on the opposite side of the vehicle.
- 6. Carry out rear suspension toe-in alignment. The data is in JTIS, Section 204-00, Specifications. Perform this operation before final tightening of the toe link to the hub carrier.
