S211-04

TECHNICAL BULLETIN

Squeaking Noise – Power Steering System – Flush System MODEL 2003 MY-ON S-TYPE

M44998-ON

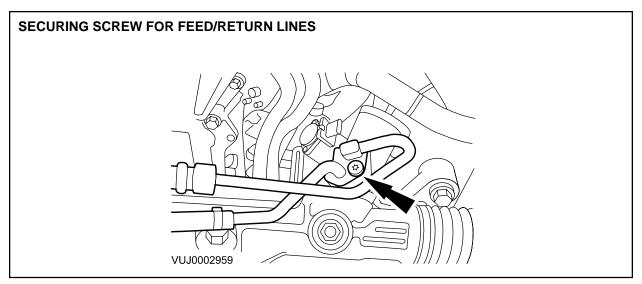
ILLUSTRATION 1

On some 2003 MY-ON S-TYPE vehicles, a squeaking noise may be apparent from the power assisted steering system when the steering wheel is rotated in either direction. The noise is caused by a seal that it internal to the steering rack. The noise can emanate through the steering column and steering wheel, making it difficult to diagnose. The system can be drained and refilled with new fluid to address the customer concern. This bulletin does not address any other PAS noises such as PAS pump or drive belt related noises.

- 10. On all vehicles, remove the PAS rack feed and return pipes securing screw (Illustration 1).
- 11. Disconnect and reposition the PAS feed and return pipes from the PAS rack.
- 12. Allow fluid to drain from system.
