S419-S140

TECHNICAL BULLETIN

Jaguar Assist Module – USA Vehicles Only –
Install Later Revision Level –
Service Action S140

MODEL 2001 MY
S-TYPE
VIN L86902-M21959

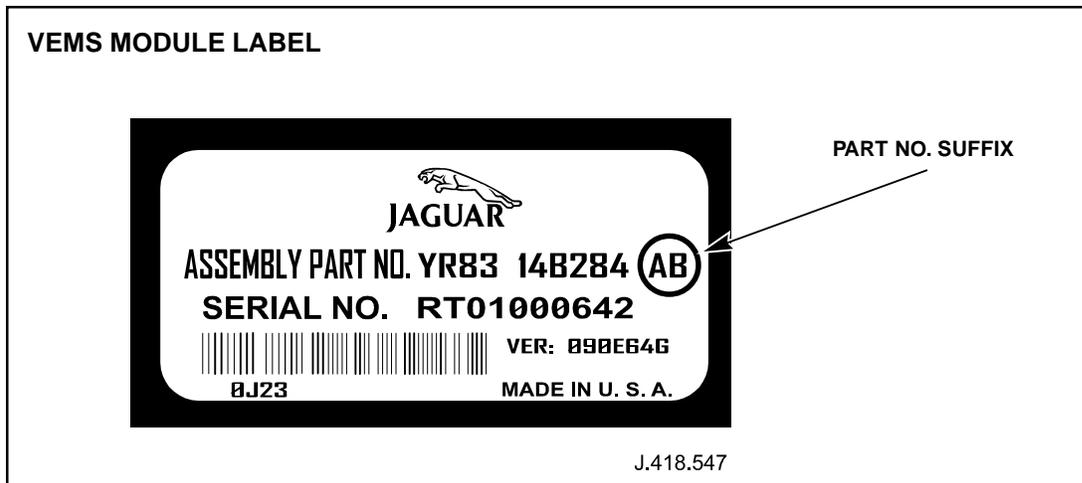
ILLUSTRATION 1

5. Remove satellite navigation system support bracket bolts.
6. Displace satellite navigation system support bracket. Locate the VEMS module and inspect the label (Illustration 1). If the label indicates an AA suffix, continue with the procedure on the next page.

If the label in Illustration 1, indicating an AB suffix to the part number, is present on the module you will need to make the activation call using the Jaguar Assist System. The upgrade will be completed automatically. The word "UPGRADED" must be marked on the label to indicate that the upgrade has been completed.

If the label in Illustration 1, indicates an AA suffix to the part number, continue as follows:
