**Water Leakage Into Rear Footwells –
 Add Drain Holes –
 Modification Procedure**

MODEL 2000-01 MY
 S-TYPE

VIN L00001-L86901

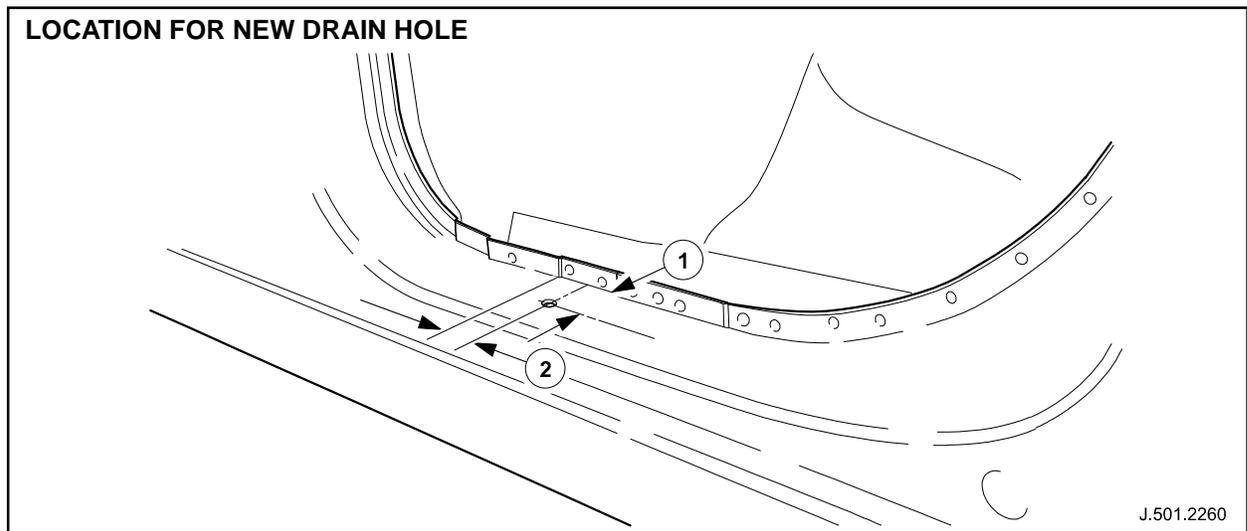
ILLUSTRATION 1

Some S-TYPE vehicles within the above VIN range may experience water leaking into the rear footwells during/after heavy rainfall. This is caused by water entering the inner door panel section via the door latch. This water is unable to drain away because the secondary door seal traps the water on the inner door aperture sill panel. To eliminate this, a procedure has been developed that involves drilling a drain hole. This modification entered production from VIN L86902.

1. Working on left side of vehicle, remove rear door aperture seal from sill flange.
2. Clean sill top surface with suitable cleaning agent.
3. Apply masking tape to area of sill to be drilled.
4. Measure from the third spot weld depression in the sill aperture flange 32.5 mm from the flange face across the sill, and draw a line on the masking tape (1, Illustration 1).
5. Measure from the third depression in the sill aperture flange 30 mm to the rear of the car and draw a line on the masking tape to cross the line drawn in step 4 (2, Illustration 1).
