# **TECHNICAL BULLETIN**

Thermostat Housing Hose – Install Additional Hose Clamp – Service Action S939 MODEL 2002-03 MY X-TYPE

VIN C00294-D28259 D29261-D32144

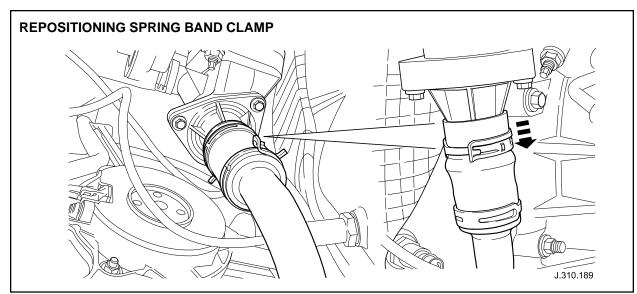
ILLUSTRATION 1

On a number of X-TYPE vehicles within the above VIN range, the spring band clamp used on the hose joint between the engine oil cooler outlet hose and the thermostat housing inlet spigot is susceptible to 'walking'. In extreme cases this can lead to the failure of the joint causing loss of engine coolant.

- 3. Reposition the hose fully upwards to abut the thermostat housing webs.
- 4. Reposition the spring band clamp close to the bulge in the hose formed by the bead of the thermostat spigot. Illustration 1.

**Note:** Spring band clamp to be close to, but not on the hose bulge.
