TECHNICAL BULLETIN

Intermittent High Idle – Replace Throttle Return Spring

19-38

MODEL XIS (4.0L) 1995-96 MY

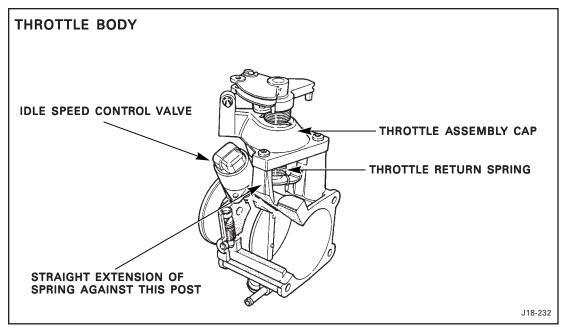
ILLUSTRATION 1

Some 1995-96 MY 4.0L XJS vehicles may occasionally exhibit a higher than target idle speed under certain driving conditions.

NOTE: It is important to note that the straight extension of the throttle return spring is against the post next to the idle speed control valve. The straight extension of the spring must rest against this post only.

- 4. Unhook the throttle return spring (Illustration 1), from the throttle shaft actuator and then remove the spring and sleeve from the shaft.
- 5. Remove the sleeve from the spring and discard the spring.
- Insert the sleeve into the replacement spring, install the sleeve and the spring on the throttle shaft and hook the spring on the actuator.

NOTE: The revised throttle return spring must be pre-loaded by rotating the straight extension one full turn counterclockwise until it can be installed in the same position against the post next to the idle speed control valve, as the original spring.
