Repairing the cup-holder mechanism, which in the past required installing a new console lid assembly, can now be done by installing a replacement mechanism in the existing lid assembly.

REPLACING CUPHOLDER MECHANISM

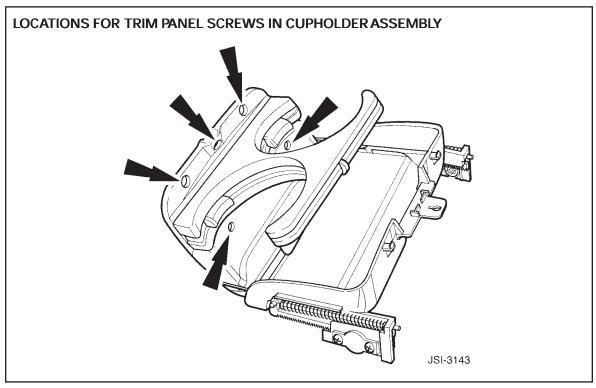
ILLUSTRATION 1

In case of a customer complaint of a broken cup-holder assembly, (shown in Illustration 1), remove the holder and install a new assembly in the cubby box lid as described on the next page.

- 4. Remove the cup holder latch retaining screw, (Illustration 3).
- 5. Remove the latch and the cup-holder mechanism with its trim panel from the lid.
- 6. Remove the five No.T8 Torx head screws, (arrowed in Illustration 1), that retain the trim panel. Remove the panel from the mechanism.
