V8 XJ Series/XK8

# **TECHNICAL BULLETIN**

2/98

Limited Throttle Opening – Secure Throttle Cable Adjusting Nut – Recall R466 MODEL 1998 MY XK8 Range 1998 MY V8 XJ Series

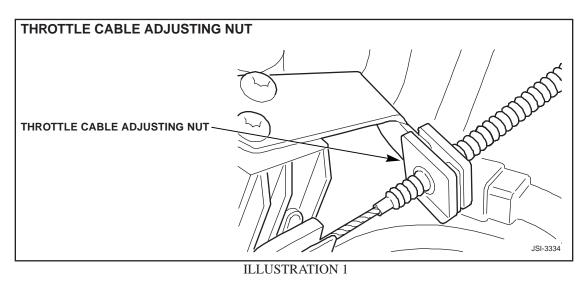
On some of the above-listed vehicles the potential exists for the adjusting nut on the outer sleeve of the throttle cable to come out of the cable bracket on the engine. Should this occur, it may possibly limit the opening of the throttle, even with the accelerator pedal fully depressed to the floor.

- 1. Open the hood and install protective fender covers.
- 2. All models: Looking into the engine compartment when standing by the left hand front wheel, examine the throttle cable adjusting nut and its bracket. If an existing tie-strap is present as in Illustration 2 below, no further action is required. If no tie strap is present (as in Illustration 1 below) proceed as follows:

- 3. All models: Press the throttle cable adjusting nut fully downwards into the abutment bracket shown in Illustration 1 below.
- Install and fully tighten a tie-strap (Part No. ADU 9028) as shown in Illustration 2, to secure the adjusting nut in its location in the bracket. Trim off any excess from the tie-strap.
  Sedan models only: Reinstall the rear engine cover, tool-box and master cylinder covers.
