501-58

TECHNICAL BULLETIN

Head Restraint Inoperative – Drive Cable Not Fully Engaged In Gearbox – Repair Method

MODEL 2003-06 MY XK Range

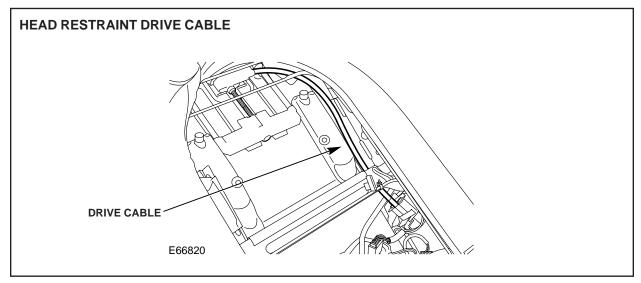
ILLUSTRATION 9

On 2003-06 MY XK Range vehicles, within the above VIN range, equipped with motorized head restraints, the head restraint drive cable may not be fully engaged in the gearbox. This condition can restrict upward and downward movement.

10. Remove the head restraint drive cable and outer sheathing (Illustration 9).
