XK8

# **TECHNICAL BULLETIN**

Squeak/Rattle From Fascia Area – Check Bulkhead Brace Fasteners MODEL 1997 MY-ON XK8 Convertible

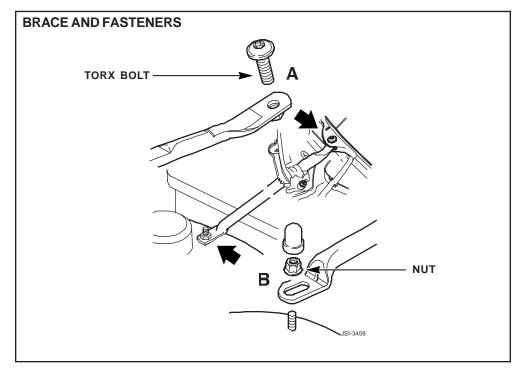
Some 1997 MY-ON XK8 convertibles may experience noise in the bulkhead area that is caused by the mountings of the bulkhead braces. Each bulkhead brace is connected between a suspension strut mounting stud at the front and an eye in the bulkhead panel at the rear. Each bulkhead brace is retained at the front by a retaining nut, (B, Illustration 1), and at the rear end by a Torx screw through the eye and a captive nut attached to the brace (A, Illustration 1). At VIN 020871 the size of the bolt was increased from T40 to T50. This checking procedure can apply to any vehicle regardless of VIN.

- 1. Remove and retain the cap from the suspension strut mounting stud and nut, (B, Illustration 1).
- 2. Remove and discard the nut.
- 3. Unscrew the Torx screw and retain it.

- 4. Remove the brace and check that the threads of the captive nut of the brace and the screw are cleared of any obstruction.
- 5. Install the brace on the suspension strut mounting stud and then install and lightly tighten a new nut.
- 6. Apply a coat of thread locking compound, to the leading threads of the Torx screw.
- 7. Align the brace to the eye, insert the screw into the captive nut and then tighten it to the torque specification:
  T40 Torx screw before VIN 020871 22-28 Nm (17-20 lb. ft.)
  T50 Torx screw from VIN 020871 40-54 Nm (30-39 lb. ft.)
- 8. Tighten the nut on the suspension strut mounting stud to 26-34 Nm (20-24 lb. ft.).
- 9. Replace the cap on the stud and nut.
- 10. Repeat the operation for the other side.
- 11. Allow the locking compound to cure and then road test to check for the suspected noise.
