Sedan Range

05.1-09

TECHNICAL BULLETIN

Uneven Cold Idle – Drivability Enhancements – ECM Upgrade

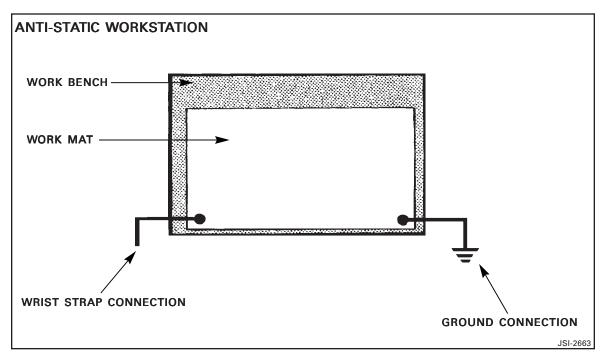
ILLUSTRATION 1

CAUTION! The following steps should only be carried out while working at an anti-static workstation (Illustration 1) and wearing a grounding wrist strap.

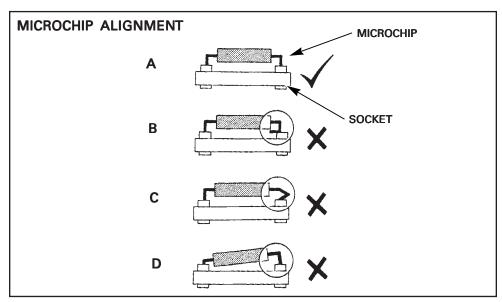
ILLUSTRATION 5

CAUTION!The microchip **MUST** lie parallel to the printed circuit board with all the pins engaged into the socket (conditionA, Illustration 5). Permanent damage to the chip is likely in conditions B or C. Malfunctions will occur with partial engagement as in condition D.
