**Steering Rack – Leak at Transfer Pipe
Union Nut – Replace O-rings**

MODEL 1995-97 MY
Sedan Range
VIN 720001-812255

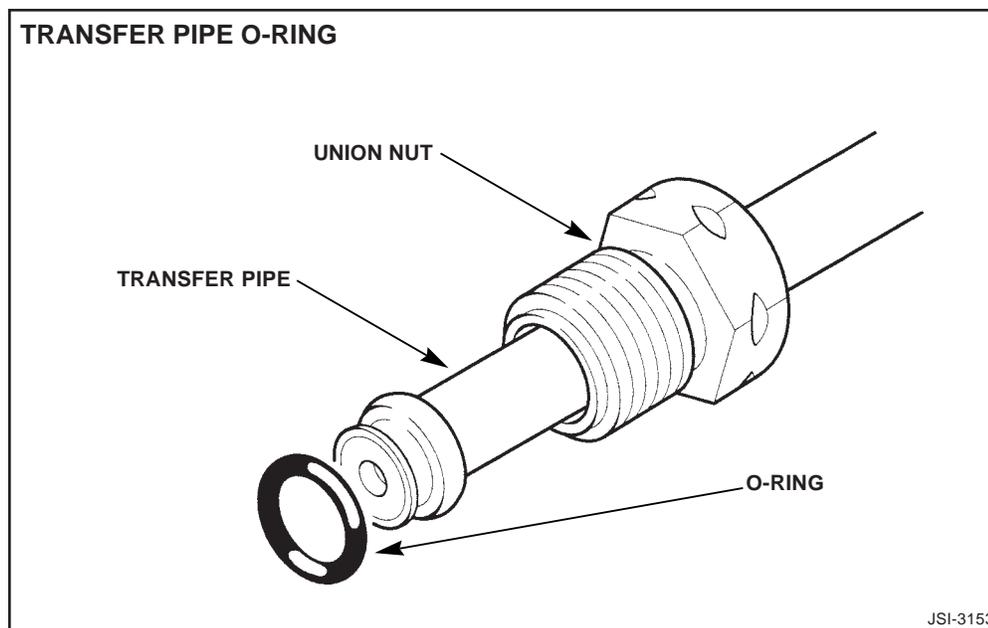
ILLUSTRATION 1

The steering rack of some 1995-97 Sedan Range vehicles may leak at one of the transfer pipe union nuts. The cause of the leak is damage to the O-ring seal beneath the union nut caused during installation. Before replacing the entire steering rack, the O-ring (Illustration 1) should be replaced and the system tested.

7. Remove the O-rings from the threaded ports in the pinion housing where the feed and return pipes were installed.
8. Loosen the transfer pipe union nuts, in both the rack and the pinion housings, and then remove the pipes from the rack.

9. Remove the O-rings from the threaded ports, in both the rack and the pinion housings, where the transfer pipes were installed.
10. Discard the O-rings that were removed.

11. Thoroughly clean the areas around the threaded ports, lubricate the replacement O-rings and then install them to the transfer pipes.
12. Install the transfer pipes to the rack assembly, taking care not to damage the O-rings against the thread in the port.

13. Thread the union nuts and lightly tighten them while checking that the pipes and the O-rings are properly seated in the bores.
14. Using a crowfoot wrench on a torque wrench, tighten the union nuts to 7 - 8 Nm (5.2 - 5.9 lb ft or 62 - 70.8 lb in).
