Sedan Range

TECHNICAL BULLETIN

Front Suspension – Knocks – New "V" Mount Introduced

MODEL 1995 MY Sedan Range VIN

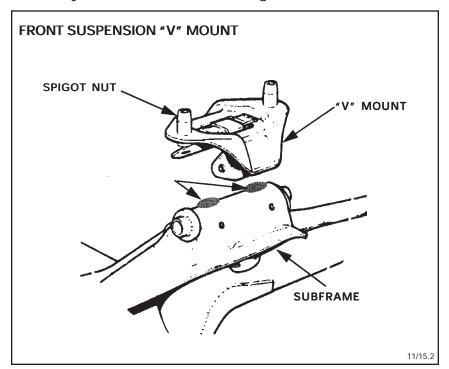
ILLUSTRATION 1

Knocks or rattles from the front suspension of 1995 MY Sedan Range vehicles within the above VIN range may be caused by the front suspension "V" mount spigot nuts contacting the front subframe (crossbeam). A new "V" mount with shorter spigot nuts was introduced in production at VIN 722758.

If a customer complains of a hard knock from the front suspension of a 1995 MY Sedan Range vehicle within the above VIN range when driving over a rough road surface, check for evidence of contact between the front suspension "V" mount spigot nuts and the front suspension subframe (Illustration 1). If contact is found, replace the existing front suspension "V" mounts with new "V" mounts (part number MNA 2360AD) as follows:

- 16. Remove the "V" mounts from the subframe.
- 17. Install the new "V" mounts on the subframe. Torque the bolts to 11.4 lb. ft. \pm 2.6 lb. ft. (15.5 Nm \pm 3.5 Nm).
