Sedan Range

14-04

TECHNICAL BULLETIN

Cooling System – Fan Fuse Failure

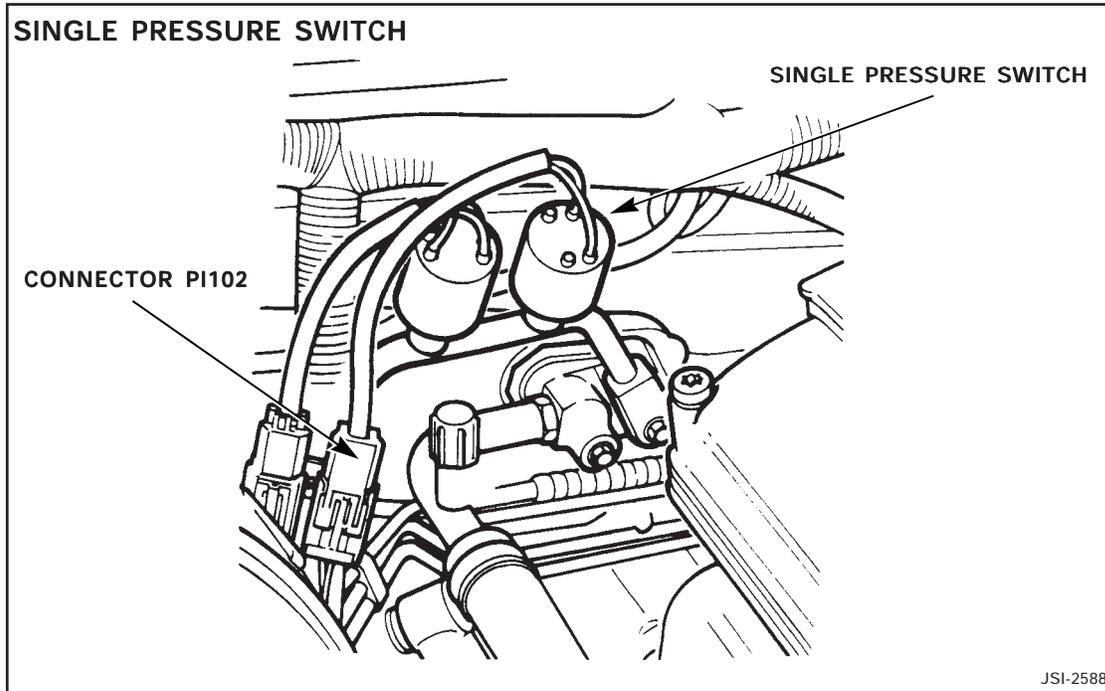
ILLUSTRATION 1

The cooling fan circuit protection fuses F11 (30 Amp) and F17 (30 Amp) located in the LH Engine Bay Fuse Box may fail intermittently on 1995 MY XJ6 and XJR vehicles. The problem may be caused by a defective single pressure switch which controls slow fan speed operation.

If the single pressure switch is defective, and refrigerant pressure rises enough to close the triple pressure switch, the fans will switch directly to high speed mode from off. This results in a higher current draw than the normal sequence of switching from low to high speed. The higher current draw may blow either or both fuses F11 and F17.

3. Disconnect the wiring harness of the single pressure switch at the white 2-way connector (PI102), Illustration 1.
4. Jump the terminals on the harness side of the connector. Switch the ignition ON and check if the cooling fans run at slow speed.

- If the cooling fans operate at slow speed, the single pressure switch is suspect; continue with step 6.
 - If the cooling fans do not operate, the switch is probably OK. Perform normal electrical fault tracing on the fan circuit.
