Sedan Range

19.6-07

TECHNICAL BULLETIN

Squeaks & Rattles – Noise From Fascia – Movement of Steering Column Upper Bracket

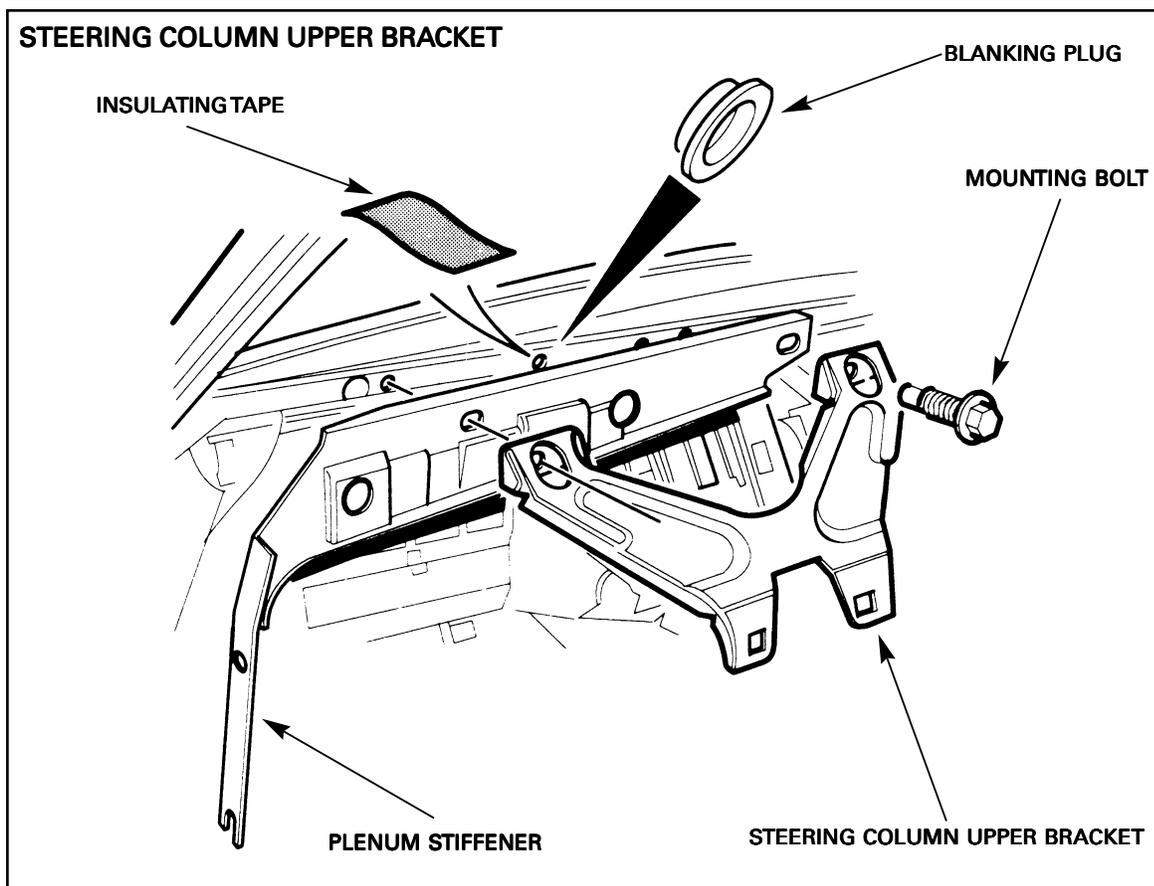
ILLUSTRATION 1

Some 1995 MY Sedan Range vehicles within the above VIN range may exhibit a noise that appears to come from the instrument area. The noise may be caused by movement of the steering column upper bracket against the plenum stiffener, Illustration 1, and the surface of the plenum.

The upper mounting bracket can move if it is not in full contact with the surface of the plenum. Blanking plugs or excess hardened sealer can prevent full contact thereby allowing movement.

11. Remove the retaining bolts and move the stiffener to obtain access to the plenum, Illustration 1.
12. Remove and discard the blanking plugs from the unused holes in the plenum (Illustration 1). Cover the holes with lengths of insulating tape to keep them air tight.

13. Clean any excess sealer from the surface of the plenum around the area of the mounting bolt weld nuts. This area should be flat without any projections.

14. If the paint surface around the holes has been damaged, paint the surface with a zinc-based paint.
15. Place the plenum stiffener, Illustration 1, into position against the A pillar and start the retaining bolts without final tightening.

16. Lift the steering column assembly from the temporary support and loosely attach the upper mounting bracket and the plenum stiffener to the plenum using new bolts. Do not final tighten the bolts.

18. Center the steering column with the instrument cluster and tighten the new bolts that secure the upper mounting bracket to the plenum to 17-23 Nm.
19. Clip the wiring harness connectors to the steering column bracket.
