A/C - Does Not Cool Sufficiently

No: JTB00183

Air Conditioning System Not Cooling Sufficiently

S-TYPE (X200) 3.0L V6 only

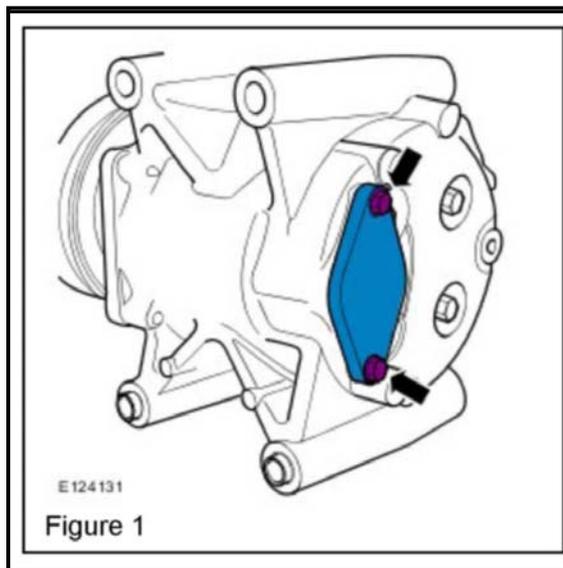
A/C compressor shown removed for clarity.

Note the position of the cover. (Figure 1)

4. Remove the A/C compressor valve cover:

^Remove the two bolts.

^Evenly and progressively tighten the bolts to 15Nm (11 lbf ft). (Figure 1)

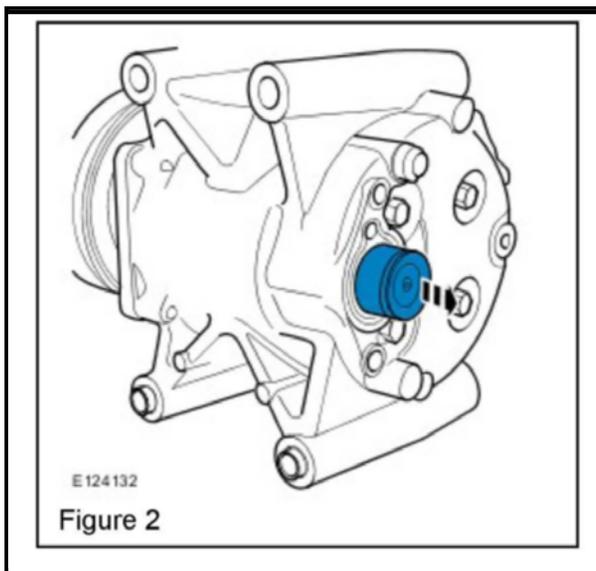
NOTE: Note position of the A/C compressor valve. (Figure 2)

5. Remove the A/C compressor valve. (Figure 2)

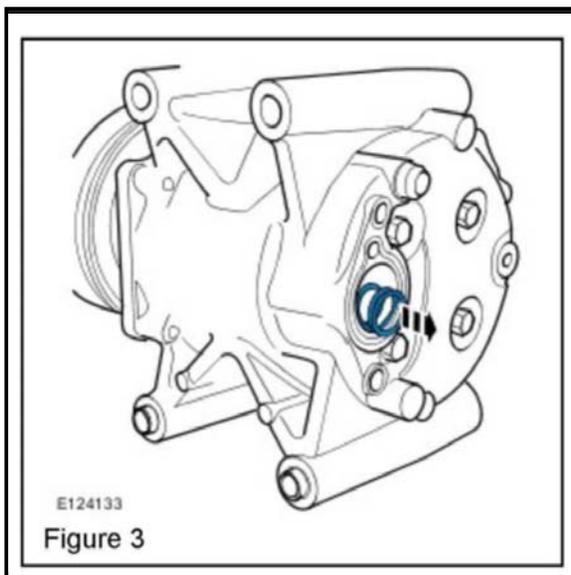
6. Remove the A/C compressor valve spring. (Figure 3)

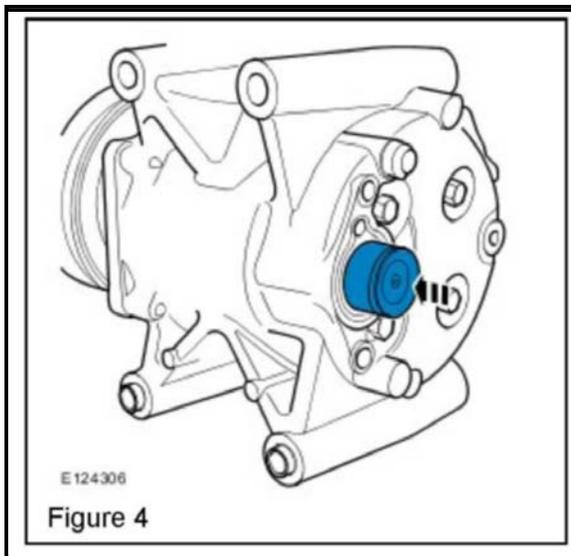
7. Install the A/C compressor valve. (Figure 4)

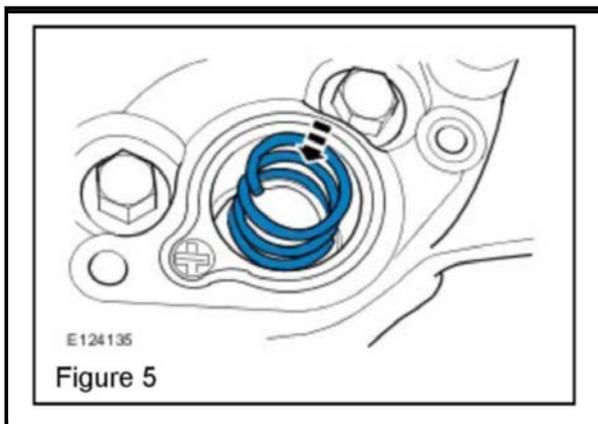
8. Install the A/C compressor valve spring. (Figure 5)
