TECHNICAL BULLETIN

Front Wheel Hub – Accumulation Of Excess Grease – Grease Deflector Ring

1997 MY-ON XK8 Range 1998 MY-ON V8 Sedan NA VIN

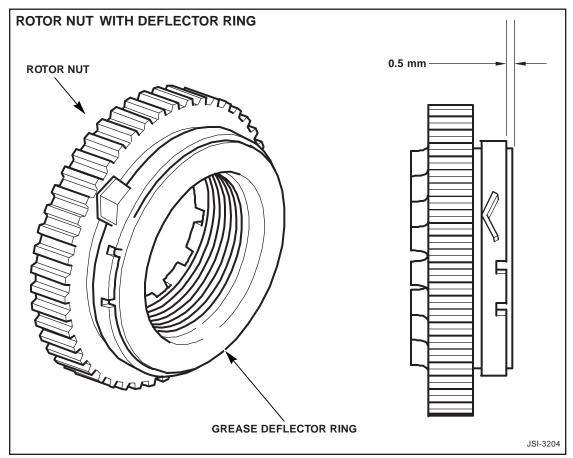
ILLUSTRATION 1

The deflector ring is a light interference fit on the nut and must be installed 0.5 mm from the edge of the hub as shown in Illustration 1.

Vehicles after the above VIN are equipped with a nylon grease deflector ring on the rotor nut of each front hub. This ring prevents the build-up of excess grease near the seal which could collect dirt that could damage the seal.

When performing a repair on a 1997 MY-on XK8 that requires removing the rotor nut, install a grease deflector ring during reassembly. 1998 MY-on vehicles must always have the deflector ring reinstalled during any service to the front hub.
