Repairing the cup-holder mechanism, which in the past required installing a new console lid assembly, can now be done by installing a replacement mechanism in the existing lid assembly.

REPLACING CUPHOLDER MECHANISM

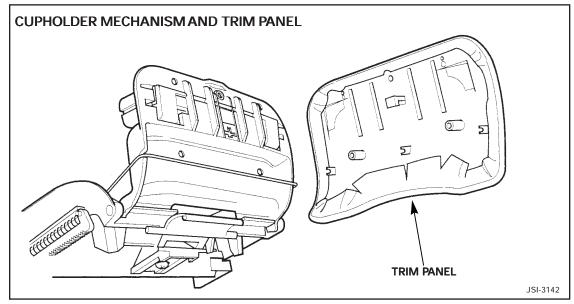
Note: The trim panel is released by pulling the bottom edge out a little and then pushing upwards, to disengage the hooked projection on the rear of the trim pad from the mechanism.

- 4. Remove the cup holder latch retaining screw, (Illustration 3).
- 5. Remove the latch and the cup-holder mechanism with its trim panel from the lid.
- 6. Remove the five No.T8 Torx head screws, (arrowed in Illustration 1), that retain the trim panel. Remove the panel from the mechanism.

7. Discard the damaged mechanism.
