Sedan Range

TECHNICAL BULLETIN

Oil Pressure Gauge – Fluctuation or Low Pressure Readings – Modification Procedure

MODEL 1995 MY
Sedan Range
VIN
720001 - 746613

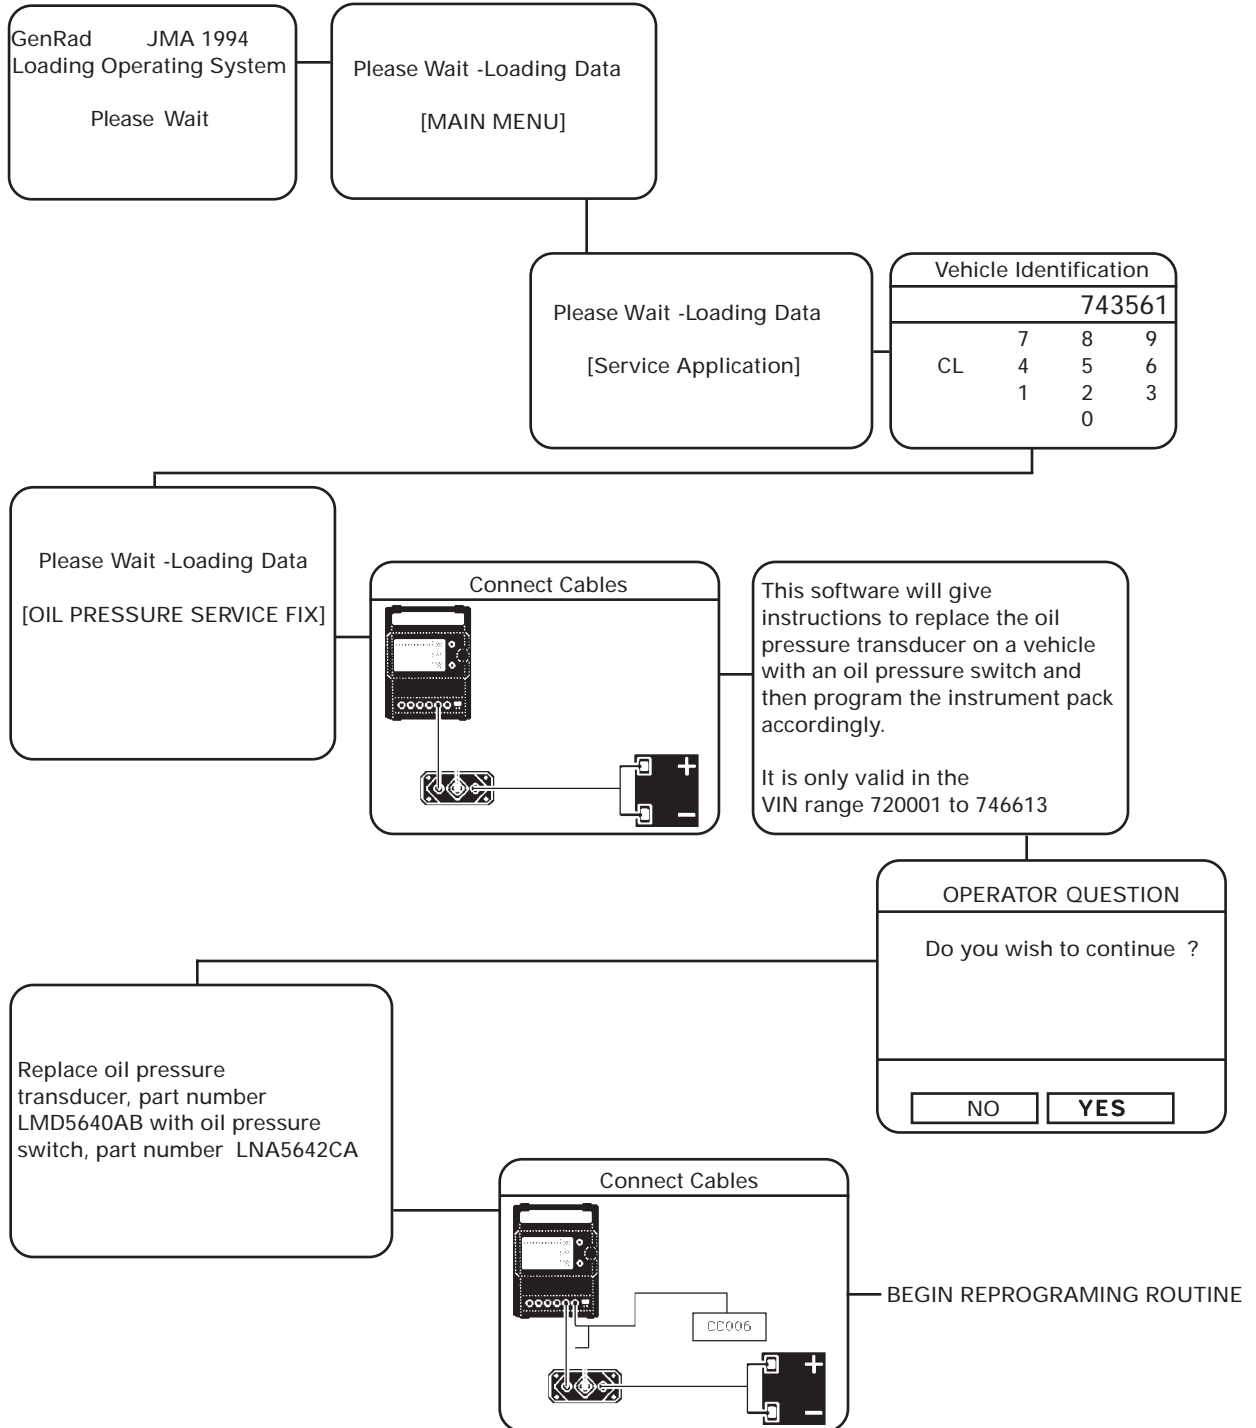
SERVICE ACTION DISC VERSION 1.0 SETUP ROUTINE:

Service Action Disc Version 1.0 is designed to reprogram the instrument pack oil pressure gauge after the oil pressure sensor is replaced by a new oil pressure switch.
