XK8

303-06

TECHNICAL BULLETIN

Part Load Breather Line - Proper Routing

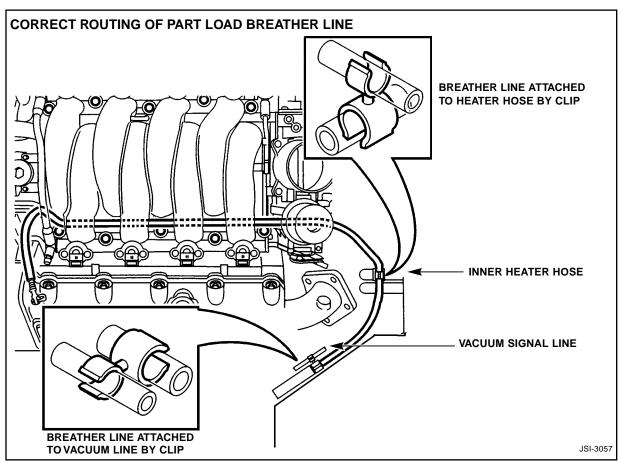
The part load breather line on XK8 vehicles can be damaged if it is not routed properly after servicing the vehicle.

After performing any work in the engine compartment that may have required disconnecting the part load breather line, observe the following:

- The part load breather line must follow the routing under the intake manifold and along the bulkead wall as indicated in Illustration 1.
- The part load breather line must be attached to the vacuum signal line by the clip.
- The part load breather line must be above and attached to the inner heater hose by the clip.
- The part load breather line must be positioned above the fuel lines.
